**Flood Control Project Maintenance
Levee Inspections**

Fall 2016 Levee Maintenance Deficiency Summary Report

Sacramento River Basin

Sutter Maintenance Yard Maintenance Area 0003

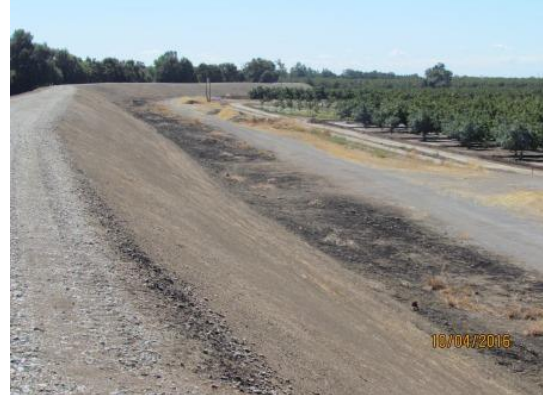
Photo 1 of 1 : FA_2016_MA0003_195_11_20161007_00026.jpg

| Very well maintained vegetation. Fall 2016. | | | | | |

View of very well maintained vegetation, landside looking downstream. Fall 2016.

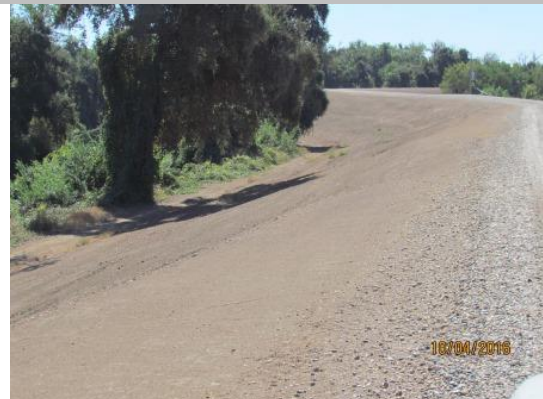
Photo 1 of 1 : FA_2016_MA0003_195_12_20161007_00027.jpg

| Very well maintained vegetation. Fall 2016. | | | | | |

View of very well maintained vegetation, waterside looking downstream. Fall 2016.

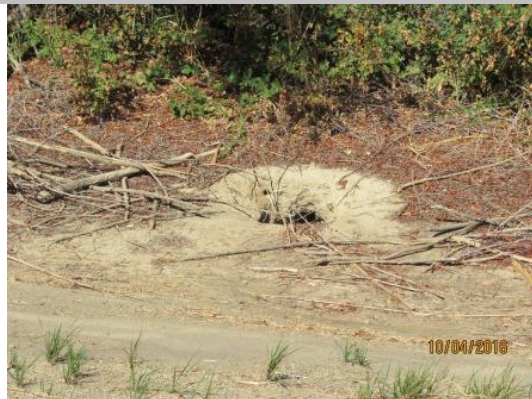
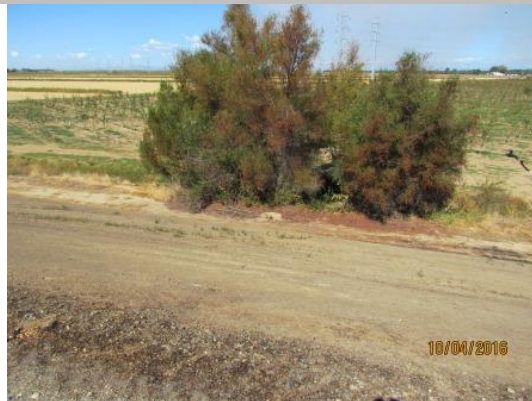
| There is a rodent hole on the landward toe road approximately 8" in diameter that needs to be repaired. Fall 2016. | | | | | |

This photo was taken from the landward levee slope near the toe road facing north looking at an approximately 8" rodent hole. Fall 2016.

This is another photo of the rodent hole to show its relationship to the levee toe, toe road, and drainage ditch. Fall 2016.

| A3 : No rodents visible, but rodent burrows visible; need to backfill and compact or grout burrows. | | | | | |

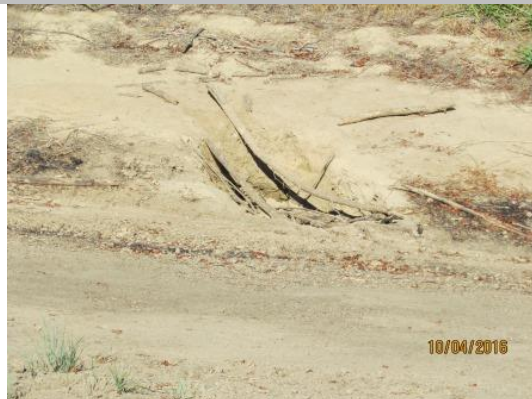
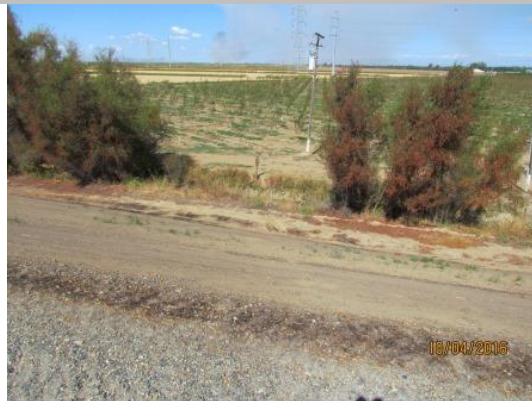
View of large hole at the landside levee toe. Look to be caused by a larger animal other than squirrels. Fall 2016.

View from the crown of where this hole is. Fall 2016.

| A3 : No rodents visible, but rodent burrows visible; need to backfill and compact or grout burrows. | | | | | |
| Repair animal hole at landside levee toe. Fall 2016. | | | | | |

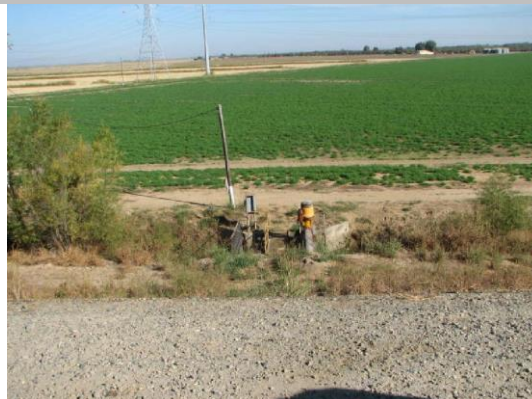
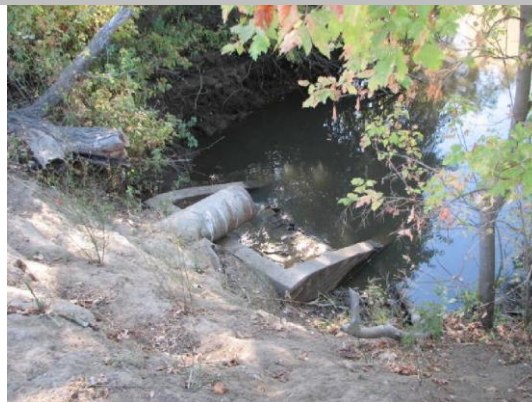
FS_ID:50237
DS_ID:17091
EP_NO: 13624
Repair Type: Non-Urgent
Crossing Status: Found
UCIP Comments: 10/10/2016 Still no flap gate on the WS end of this pipe but being that its an Up-and-Over pump design im not sure if its even needed. (DWR Sutter Yard - afreitag)4/18/2016 No repairs have been made to the pipe yet. (DWR Sutter Yard - afreitag)5/12/2015 Water level high in WS ditch so could not see WS end of crossing. Do not believe that repairs have been made yet. (DWR Sutter Yard - afreitag)11/17/2014 Same as last inspection. (DWR Sutter Yard - afreitag)5/14/2014 Pipe section that was suspected of leaking was dug up and deemed to be in good condition. No signs of leaks were found. (DWR Sutter Yard - afreitag)10/30/2013 Same as last inspection. (DWR Sutter Yard - afreitag)5/21/2013 SBFCA project recommends replacing in accordance with title 23. Hole in slope along outside of standpipe thats about 1 foot deep with moisture in the bottom. Dirt inside standpipe around siphon breaker also wet indicating there may be a leak. Need to investigate source or moisture. (DWR Sutter Yard - afreitag)

FIELD_STRUCT_DESC: 20-inch steel drainage pipe through the levee 3 feet below the crown. Siphon breaker on the waterside (WS) shoulder. Open on the WS end. Pump in ditch located on the landside (LS). (Permit No. 13624, 1983 - Danna and Danna, Inc.) [Additional Reference(s): DWR Levee Log, 2005].
FS Date: 10/11/2016 12:03:36 PM

Pump on concrete headwall at LS toe.

Pipe at outlet on WS toe

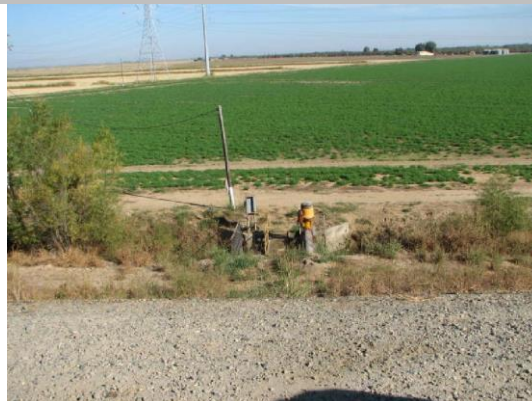
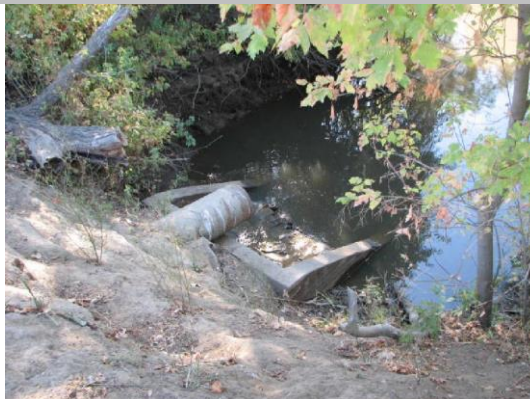
| FS_ID:50238 DS_ID:17092 EP_NO: N/A Repair Type: Urgent Crossing Status: Found UCIP Comments: 10/10/2016 WS pipe end was underwater for inspection but the sandbags still appear to be in place. (DWR Sutter Yard - afreitag)4/18/2016 No repairs have been made to the pipe yet. (DWR Sutter Yard - afreitag)5/12/2015 Water level high in WS ditch so could not see WS end of crossing. Do not believe that repairs have been made yet. (DWR Sutter Yard - afreitag)11/17/2014 Same as last inspection. (DWR Sutter Yard - afreitag)5/14/2014 Same as last inspection. (DWR Sutter Yard - afreitag)10/30/2013 Same as last inspection. (DWR Sutter Yard - afreitag)5/21/2013 SBFCA project recommends replacing in accordance with title 23. High water levels in WS ditch have pipe ends underwater but repairs have not yet been completed but are planned for when water levels drop. (DWR Sutter Yard - afreitag)10/10/2012 Flap gates not visible on waterward headwall and it appears as though they have been replaced by sandbags. Slide gates on LS appear to be closed yet water leaks excessively from the WS at the sandbagged headwall. (DWR UCIP - wwylie) FIELD_STRUCT_DESC: 1 of 2. 18-inch steel drainage pipe through the levee, 32 feet below the crown. Flap gate on the waterside (WS) end. Slide gate on the landside (LS) end at concrete headwall. Concrete "U" shaped headwall at the WS toe. [Additional Reference(s): DWR Levee Log, 2005. USACE Sacramento O&M Manual 143, August 1955 (Station 982+00)]. FS Date: 10/11/2016 12:20:54 PM | | | | | |

Concrete headwall with walkway and slide gates at LS toe.

FS_ID:50238
DS_ID:17092
EP_NO: N/A
Repair Type: Urgent
Crossing Status: Found
UCIP Comments: 10/10/2016 WS pipe end was underwater for inspection but the sandbags still appear to be in place. (DWR Sutter Yard - afreitag)4/18/2016 No repairs have been made to the pipe yet. (DWR Sutter Yard - afreitag)5/12/2015 Water level high in WS ditch so could not see WS end of crossing. Do not believe that repairs have been made yet. (DWR Sutter Yard - afreitag)11/17/2014 Same as last inspection. (DWR Sutter Yard - afreitag)5/14/2014 Same as last inspection. (DWR Sutter Yard - afreitag)10/30/2013 Same as last inspection. (DWR Sutter Yard - afreitag)5/21/2013 SBFCA project recommends replacing in accordance with title 23. High water levels in WS ditch have pipe ends underwater but repairs have not yet been completed but are planned for when water levels drop. (DWR Sutter Yard - afreitag)10/10/2012 Flap gates not visible on waterward headwall and it appears as though they have been replaced by sandbags. Slide gates on LS appear to be closed yet water leaks excessively from the WS at the sandbagged headwall. (DWR UCIP - wwylyie)

FIELD_STRUCT_DESC: 1 of 2. 18-inch steel drainage pipe through the levee, 32 feet below the crown. Flap gate on the waterside (WS) end. Slide gate on the landside (LS) end at concrete headwall. Concrete "U" shaped headwall at the WS toe. [Additional Reference(s): DWR Levee Log, 2005. USACE Sacramento O&M Manual 143, August 1955 (Station 982+00)].
FS Date: 10/11/2016 12:20:54 PM

Concrete U shaped headwall on WS toe filled in with Sandbags. 16-inch pipe shown over top of headwall.

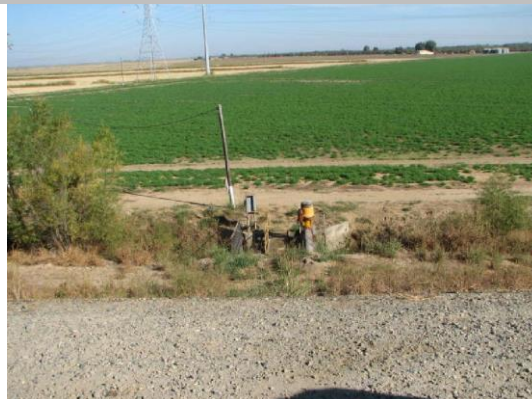
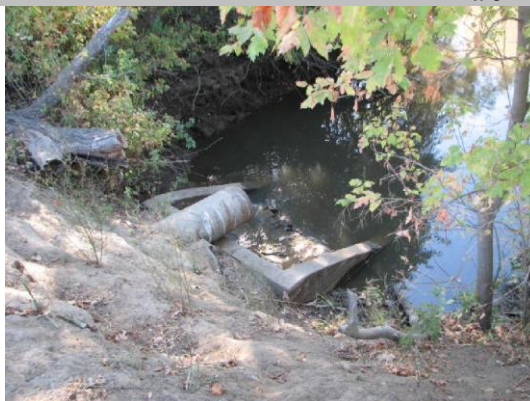
FS_ID:50239
DS_ID:17136
EP_NO: N/A
Repair Type: Urgent
Crossing Status: Found
UCIP Comments: 10/10/2016 WS pipe end was underwater for the inspection but the sandbags appear to still be in place. (DWR Sutter Yard - afreitag)4/18/2016 No repairs have been made to the pipe yet. (DWR Sutter Yard - afreitag)5/12/2015 Watelevel high in WS ditch so could not see WS end of crossing. Do not believe that repairs have been made yet. (DWR Sutter Yard - afreitag)11/17/2014 Same as last inspection. (DWR Sutter Yard - afreitag)5/14/2014 Same as last inspection. (DWR Sutter Yard - afreitag)10/30/2013 Same as last inspection. (DWR Sutter Yard - afreitag)5/21/2013 SBFCA project recommends replacing in accordance with title 23. High water levels in WS ditch have pipe ends underwater but repairs have not yet been completed but are planned for when water levels drop. (DWR Sutter Yard - afreitag)10/10/2012 Flap gates not visible on waterward headwall and it appears as though they have been replaced by sandbags. Slide gates on LS appear to be closed yet water leaks excessively from the WS at the sandbagged headwall. (DWR UCIP - wwylie)

FIELD_STRUCT_DESC: 2 of 2. 18-inch steel drainage pipe through the levee, 32 feet below the crown. Flap gate on the waterside (WS) end. Slide gate on the landside (LS) end at concrete headwall. Concrete "U" headwall at the WS toe. [Additional Reference(s): DWR Levee Log, 2005. USACE Sacramento O&M Manual 143, August 1955 (Station 982+00)].
FS Date: 10/11/2016 12:25:49 PM

Concrete headwall, slidegates, and metal walkway on LS toe.

Concrete U shaped headwall on WS toe filled with sandbags.

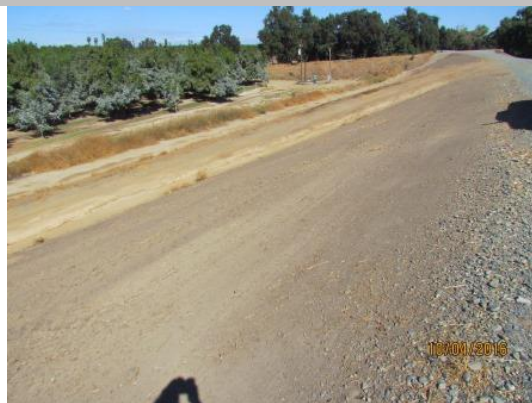
Photo 1 of 1 : FA_2016_MA0003_195_14_20161007_00033.jpg

| Rodent holes have been backfilled and no new evidenced of activity. Fall 2016. | | | | | |

Rodent holes were backfilled and no longer exist at this location. Fall 2016.

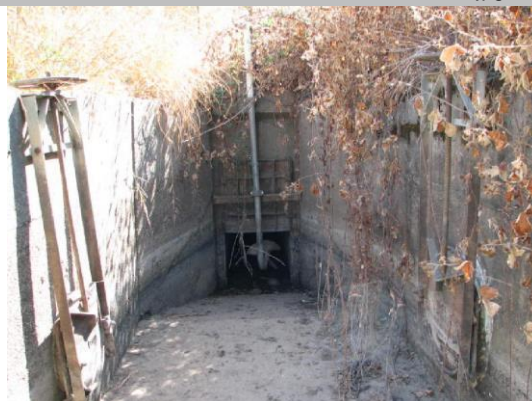
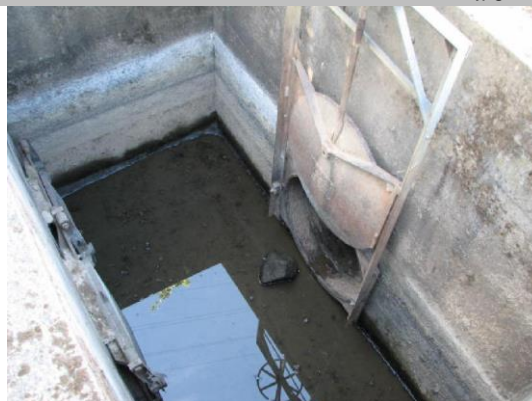
FS_ID:50244
DS_ID:17088
EP_NO: 3284
Repair Type: Non-Urgent
Crossing Status: Found
UCIP Comments: 10/10/2016 LS pipe end was mostly submerged so could not verify the connectivity between the LS headwall and WS vault. Blackberries and still overgrown on WS.(DWR Sutter Yard - afreitag)4/18/2016 WS vault is being overgrown with blackberries. They should be sprayed and cleared back. No other problems were noticeable with this crossing.5/12/2015 Only the right flapgate appeared to be abandoned. The left and middle flap gates were flowing water during the last inspection.11/17/2014 Same as last inspection.5/14/2014 Same as last inspection.10/30/2013 Same as last inspection.5/21/2013 Pumping plant was running and filling concrete vault on WS toe through the left flap gate and then flowing through levee pipe and filling irrigation ditch on LS. Left and middle flap gates appear to be connected to pumps and right gate appears abandoned. Recommend contacting owner to get more details.10/10/2012 Pumping plant has been disconnected from levee. Need to determine if abandonment is appropriate or if this is now a gravity drain with flap gate.

FIELD_STRUCT_DESC: 32-inch by 32-inch reinforced concrete irrigation culvert through the levee, approximately 28 feet below the crown. Transition between vault on the waterside (WS) and box culvert within levee section is made with a 41-inch corrugated metal pipe (CMP). Slide gate located on the landside (LS) at concrete headwall. Flap gate in concrete vault on the WS at terminal of pipes from pump structure in floodway. Pipes from pump station, located on the WS, are no longer connected. (Permit No. 3284, 1960 - Richards) [Additional Reference(s): DWR Levee Log, 2005].
FS Date: 10/11/2016 12:50:33 PM

32X32 box culvert on LS toe in Concrete U shaped channel with slide gate.

8-foot X 14-foot concrete box on WS toe with slide gate and 3 abandoned flap gates.

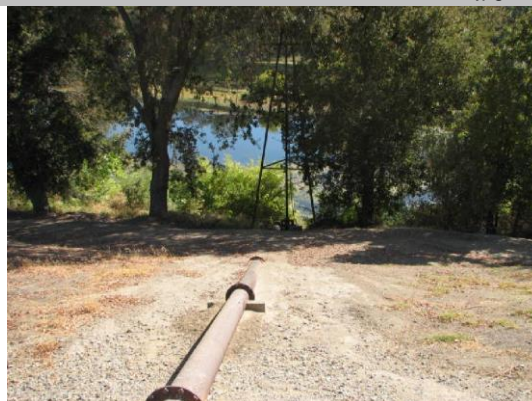
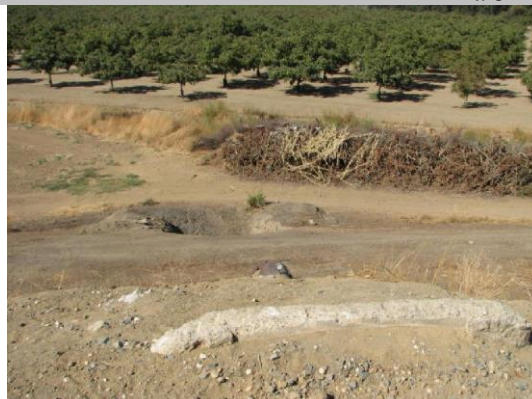
| FS_ID:50248 DS_ID:17087 EP_NO: 1730 Repair Type: Non-Urgent Crossing Status: Found UCIP Comments: 10/10/2016 Depression is still present at the LS toe but appears that it was dug out on purpose.(DWR Sutter Yard - afreitag)4/18/2016 Big depression on LS toe along the pipe alignment. 5/12/2015 Crossing appears to be in good condition. No noticeable issues to report.11/17/2014 Same as last inspection.5/14/2014 Same as last inspection.10/30/2013 Same as last inspection.5/21/2013 SBFCA project recommends replacing in accordance with title 23. Same as last inspection. FIELD_STRUCT_DESC: 12-inch steel asphalt coated irrigation pipe through the levee, 4.5 feet below the crown. Gate valve and pump located on the waterside (WS). 24-inch concrete standpipe located on the landside (LS) toe has been degraded to ground elevation and filled in with soil. Pipe remains intact. Steel tower over pump is located on the WS. (Permit No. 1730, 1959 - Robert L. Crandall). [Additional Reference(s): DWR Levee Log, 2005]. FS Date: 10/11/2016 12:55:25 PM | | | | | |

Pipe, pump, and tower on WS slope/toe.

Pipe at LS shoulder showing exposed concrete cutoff wall.

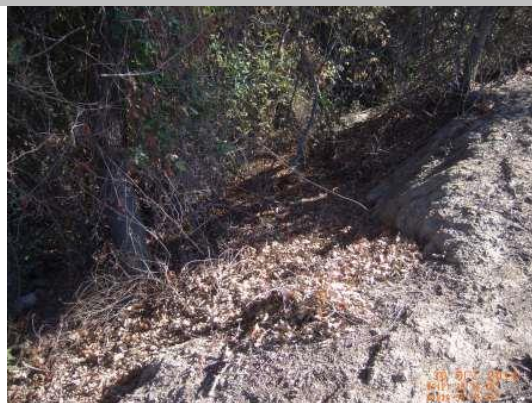
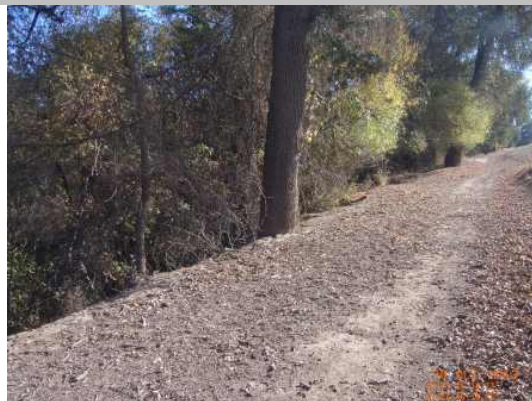
| 2013 - Minor toe scour causing gradual erosion of bank slope. Site is within ecological reserve. 2015: Last observed in 2013. [2015 Site ID: FHR_12-3_R] | | | | | |

USACE 2013 Photo #1

USACE 2013 Photo #2

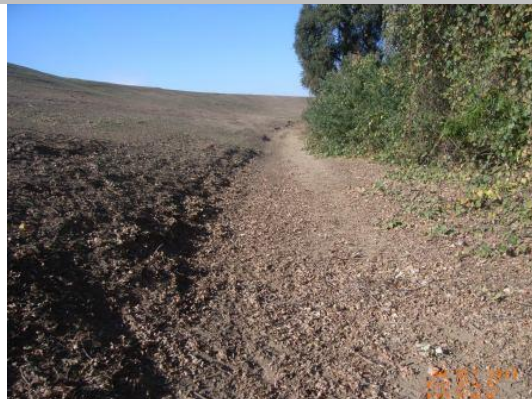
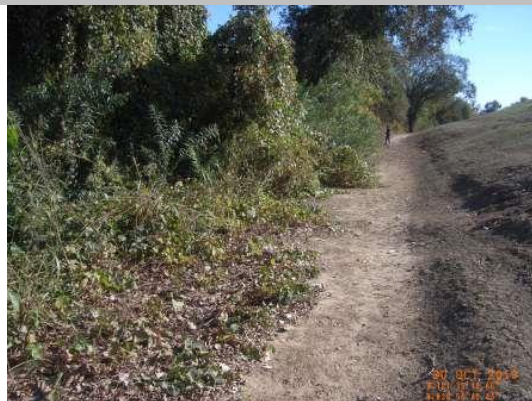
| 2015: Last observed in 2013. [2015 Site ID: FHR_12-8_R] | | | | | |

USACE 2013 Photo #1

USACE 2013 Photo #2
